Manhole Inspection Summary

Manhole # S37U1_008MH

Inspection ☐ Is Incomplete Rating: **2) Good**

Location Address: **3446 Potee St.** Cross Street: **Frankfurst Ave.**

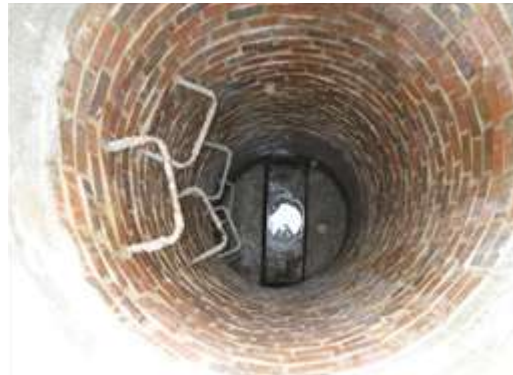
Top View

Cover Shape: **Circular** Diameter: **30** (in.) Length: (in.) Dist A/B Grade: **8** (in.)
Type: **Sanitary** Condition: **Sound** Cover Material: **Cast Iron**
Properties: ☐ Bolted ☐ Vented ☐ Water Tight ☐ Water Tight Insert

Frame Offset: **2** (in.) Condition: ☒ Sound ☐ Cracked ☐ Leaks

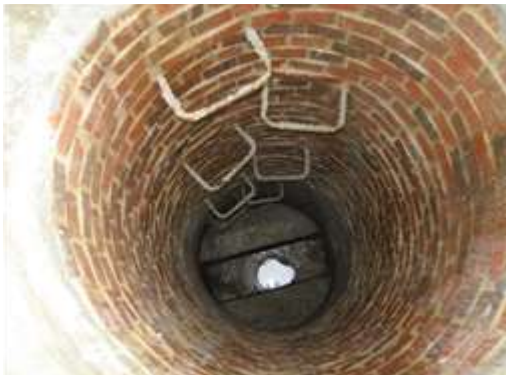
Steps Count: **12** Missing: **0** ☐ Corroded

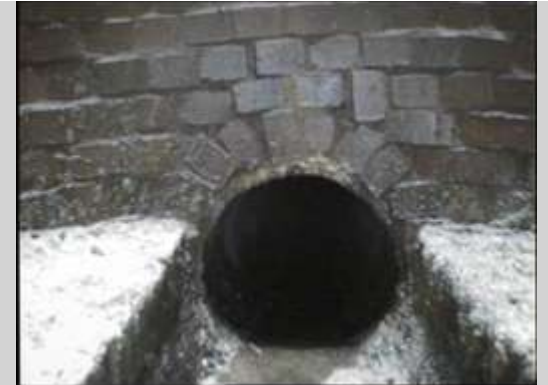
12 O'Clock Outflow

16 in. Circular Gravity Sewer
Pipe Out @ 12 O'Clock

Pipe Height: **18** (in.) Rod and Bar (Angled)
Pipe Material: **Unknown** ☐ Pipe Lined
Invert Depth: **17.90** (ft.) Flow Characteristics: **None**
Deposits: ☒ None ☐ Mud ☐ Sludge ☐ Debris ☐ Grease
Silt Depth: (in.) Deposits Extent:
Infiltration: **None** Pipe Seal Cond: **Sound**

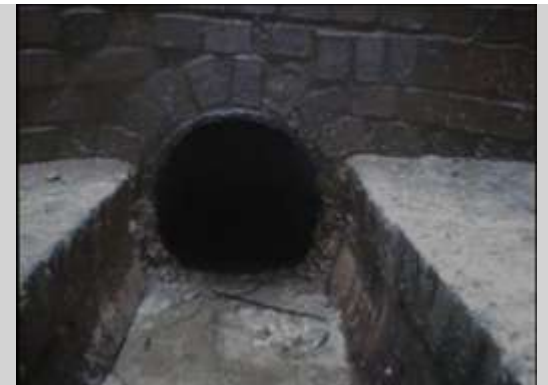
6 O'Clock Inflow

16 in. Circular Gravity Sewer
Pipe In @ 6 O'Clock

Pipe Height: **14.4** (in.) Rod and Bar (Angled)
Pipe Material: **Unknown** ☐ Pipe Lined
Invert Depth: **17.65** (ft.) Flow Characteristics: **None**
Deposits: ☒ None ☐ Mud ☐ Sludge ☐ Debris ☐ Grease
Silt Depth: (in.) Deposits Extent:
Infiltration: **None** Pipe Seal Cond: **Sound**
